Manhole Inspection Summary

Manhole # S35YY_022MH

Insp Date: **12/27/06 11:44 AM**

Location Address: **3300 CALVERT ST**

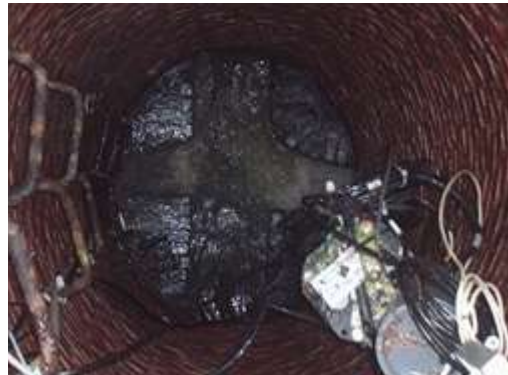
Top View

Corroded steps. Bench debris.

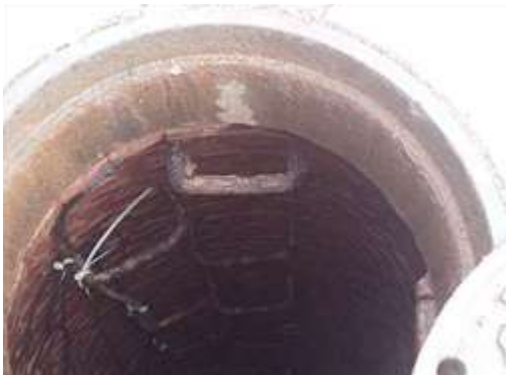
Defect

Frame Offset: **0** (in.) Condition: ☐ Sound ☐ Cracked ☒ **Leaks**

Condition: ☐ Sound ☐ Cracked ☐ Root Intrusion ☐ Loose Brick ☒ **Deteriorated**

Infiltration: ☐ None ☒ **Joint** ☐ Cracks ☐ Mortar ☐ Roots ☒ **Wall**

Frame leaks. Adjustment deterioration and infiltration.

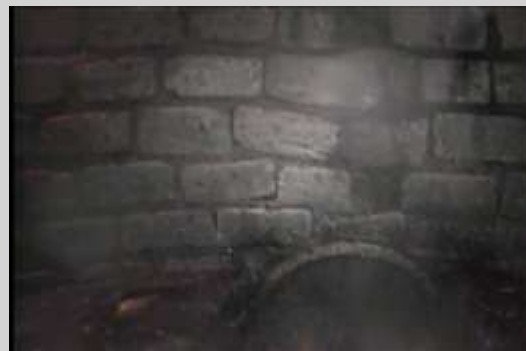
Drop In @ 3 O'Clock

Drop Condition: **Open**

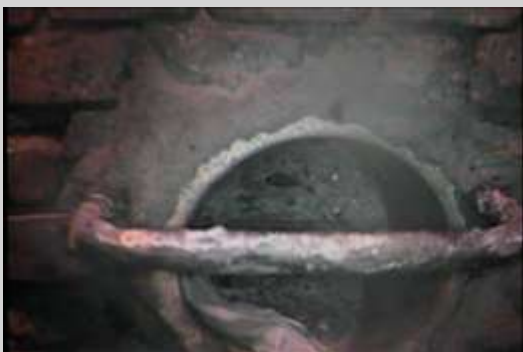
Pipe In @ 8 O'Clock

Connects To: **Stub connection / abandoned**
